## Venue safety Report

Date	Venue	Inspection Carried Out	Hazards detected
21 <sup>st</sup> October 2017	Bingham Lake	Visual	Three

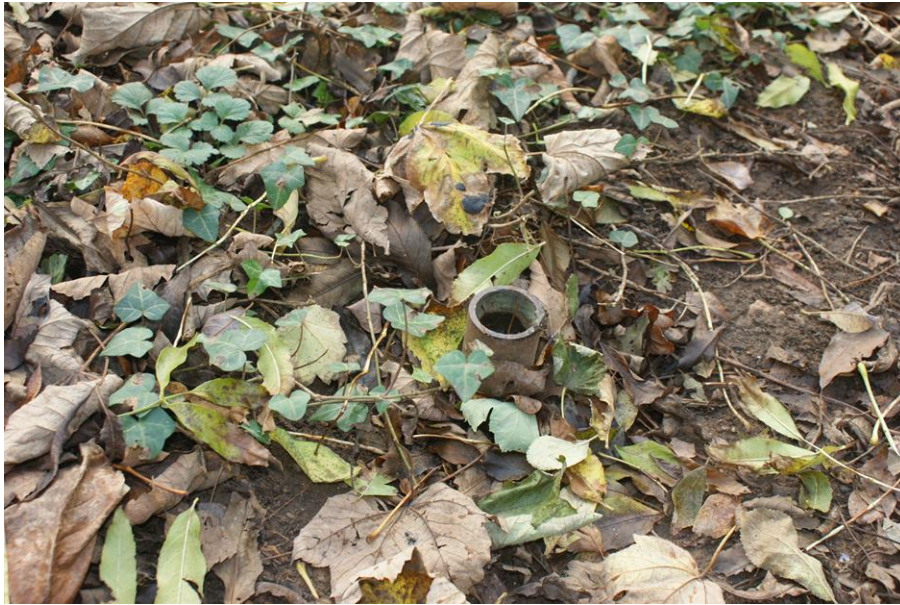
Photo 1

1. Left hand turn to road side bank (ramp up and down) – poor/eroded footsteps and tripping hazards from previous works: See photo 1
2. Bridge across dyke – I consider this to be a serious hazard to both Club members and the general public - just one sleeper is in place with no hand rail a fall from this would more than likely result in serious injury: See photo 2
3. Tree in danger of falling – a willow tree has reached a considerable height and due to age and rot is in danger of falling either into the lake or across the foot path this has the potential of causing serious injury or death: See Photo 3

Generally Bingham lake is a safe venue with need for ongoing maintenance such as regular strimming of paths and tree loping. Anglers and public alike should be responsible for their own safety and ensure that they do not take unnecessary risks. However, the three hazards I have identified do present risk to the club due to their severity and I consider that these should be addressed as a priority within the maintenance plan to ensure safety of all persons accessing the venue and as a consequence protecting the club.
