Venue safety Report

Date	Venue	Inspection Carried Out	Hazards detected
17 th December 2017	Nostell Priory	Initial Health and Safety Report	Four (with many being repeated)

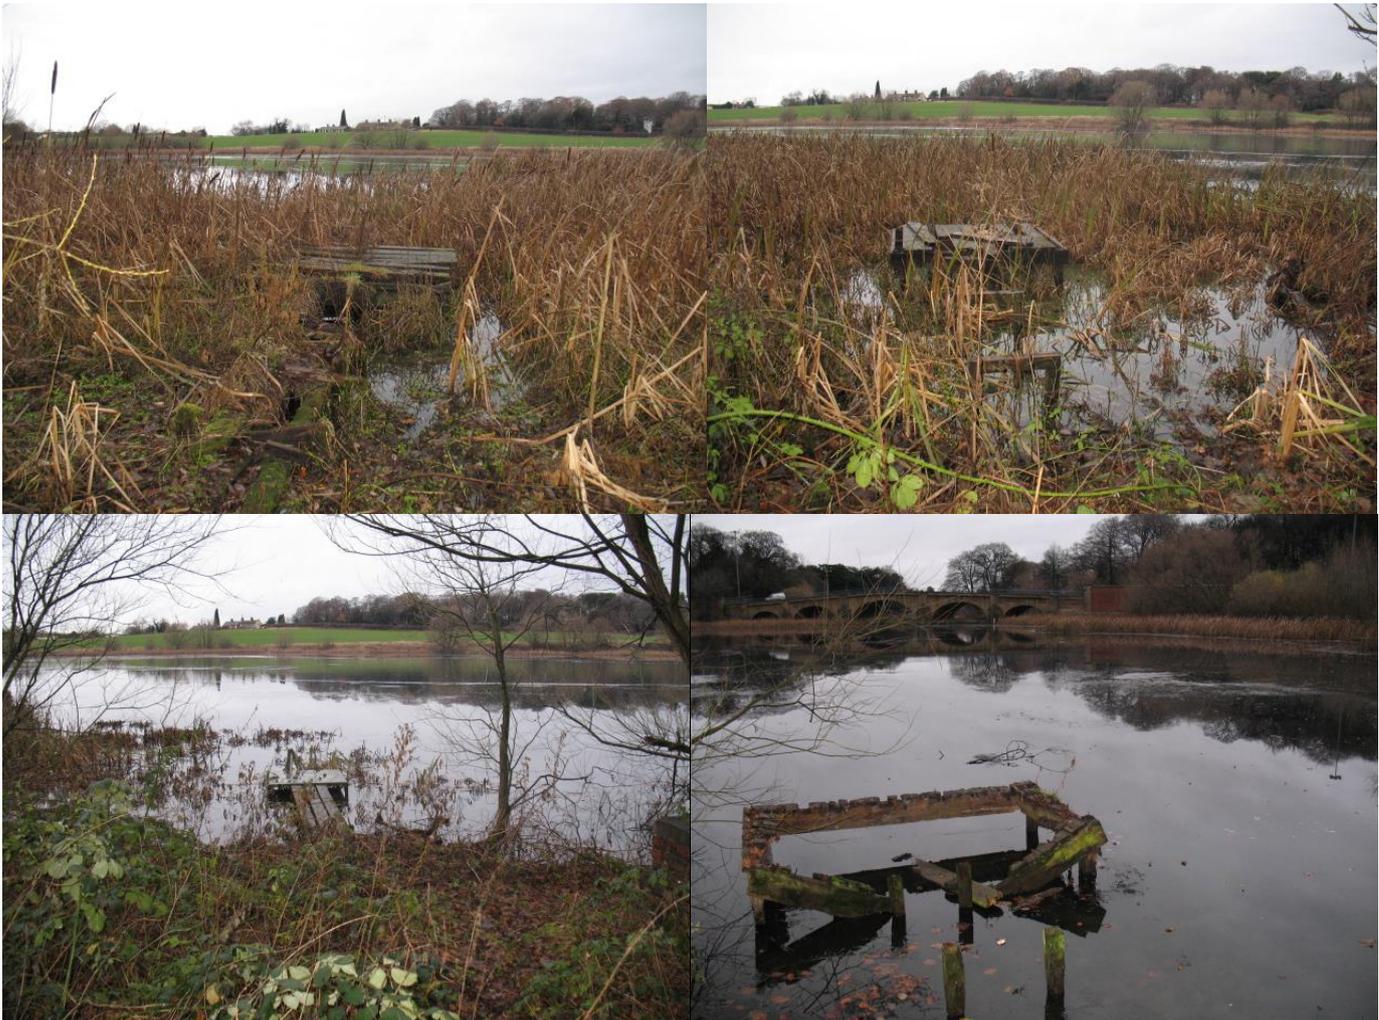
Photos of typical issues that need addressing

1. All access gang planks to fishing platforms to be removed; all current access is unsafe due to rot. (see photos) these gangways then to be replaced with a permanent and appropriate walk ways

poor and unsafe work. As an interim measure before the gang planks are removed they should be roped off and members informed of the poor/unsafe condition of all gang planks. This report considers that the majority of the work in the initial work parties will represent the most hazardous period of the clubs management of the venue and that the work parties are informed by robust risk assessments that deal with the hazards identified within this report. The committee should ensure that members are informed that the venue should be considered as 'work in progress' and informed that care must be taken when accessing and fishing, the club should make this is clear to protect itself from possible claims or prosecution. As the work progresses it is recommended that revaluation of the venue is carried out to maintain a safe venue

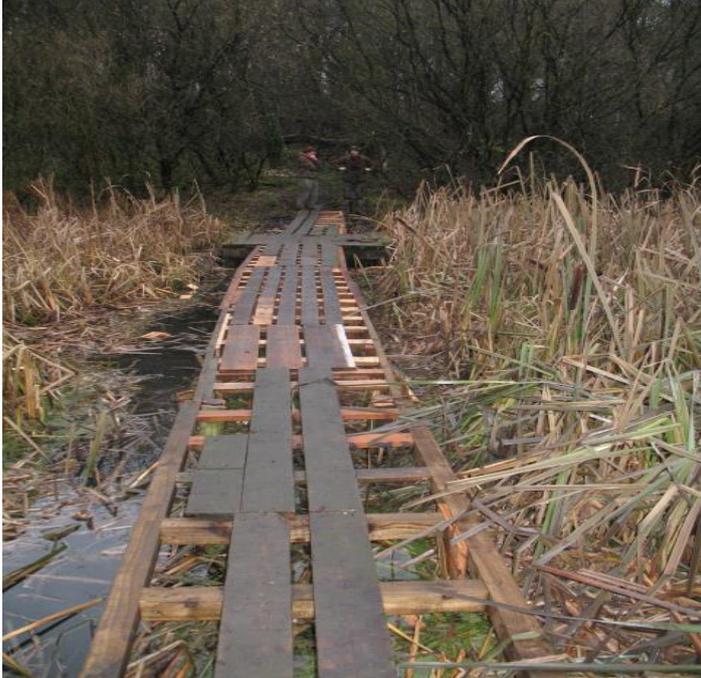
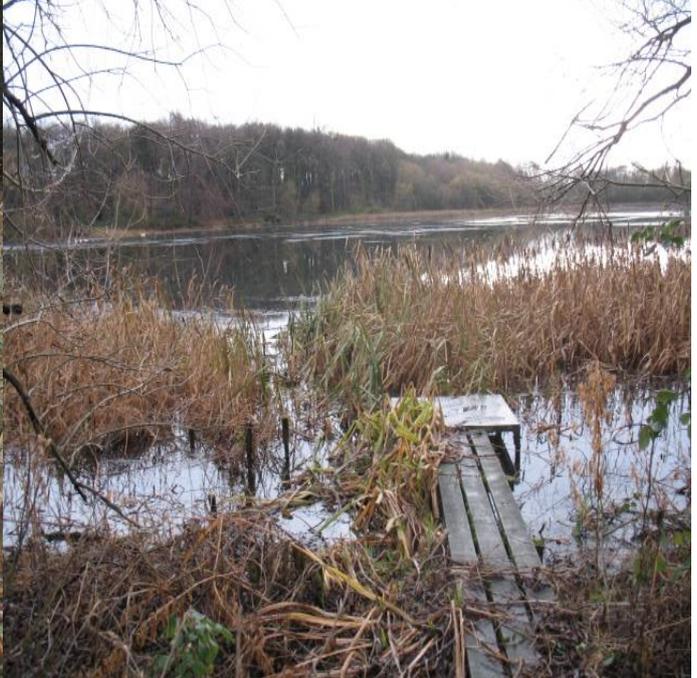
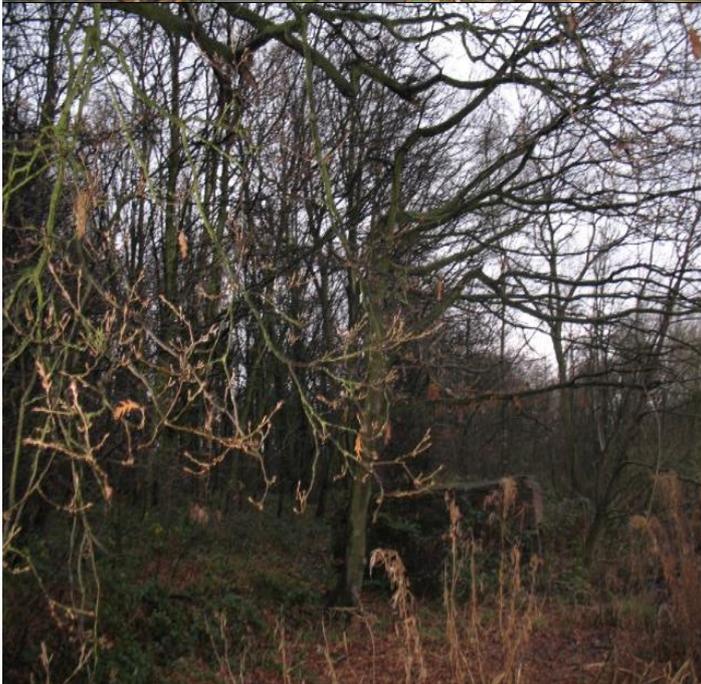
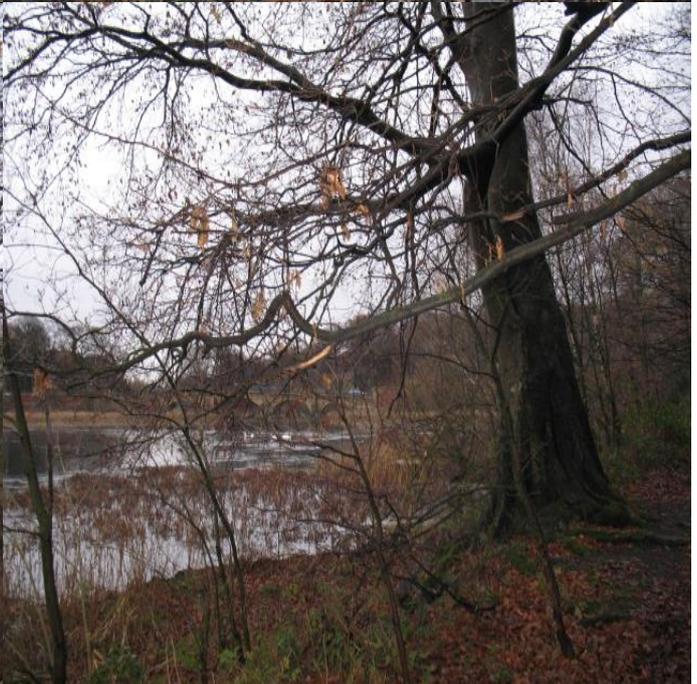
As the venue has no hazards such as fast flowing and deep water or high banks the venue should be considered a low risk/hazard venue. However, in its present state the hazards with the platforms needs addressing quickly, it was noted that recent work has been carried out to a platform(pictured) that appears to be un authorised and should be removed to prevent the club taken ownership of
